# TUNNELING OUT AT 20.85 METERS

## *Cleanup Progress at Sellafield's Pile Fuel Cladding Silo*

### By David Skilbeck

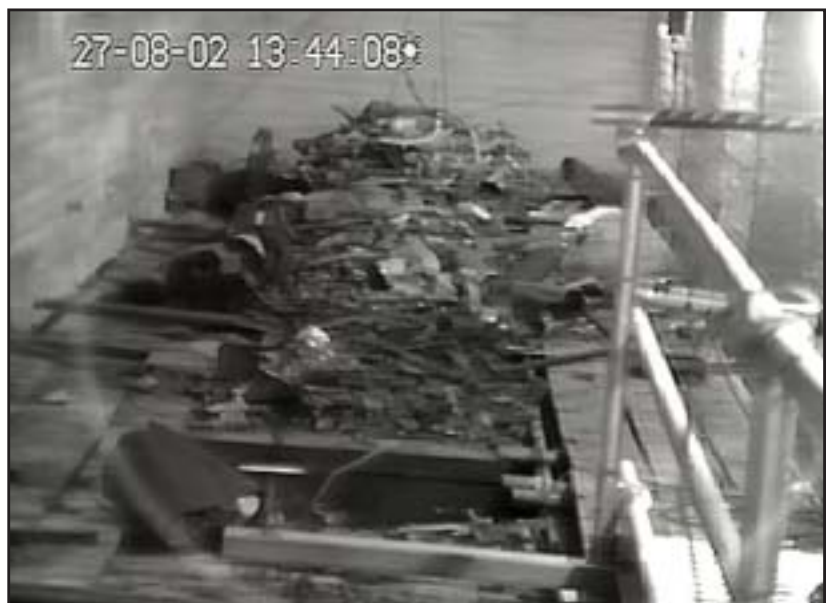
*As can be seen in this photo taken from a video image, radioactive waste dating from the 1960s jammed the tunnel charge holes leading to the storage silos, requiring a significant cleanup effort by BNG.*

The waste that had remained in the tunnel since the 1960s had to be cleared. At first workers conceived a method known as “the Pokey Stick” to poke the waste back into the storage compartments. They later developed a pole equipped with hydraulic cutters to chop up scaffolding and steel covers. With this method they successfully cleared all of the bulk waste and scaffolding into the silo compartments.

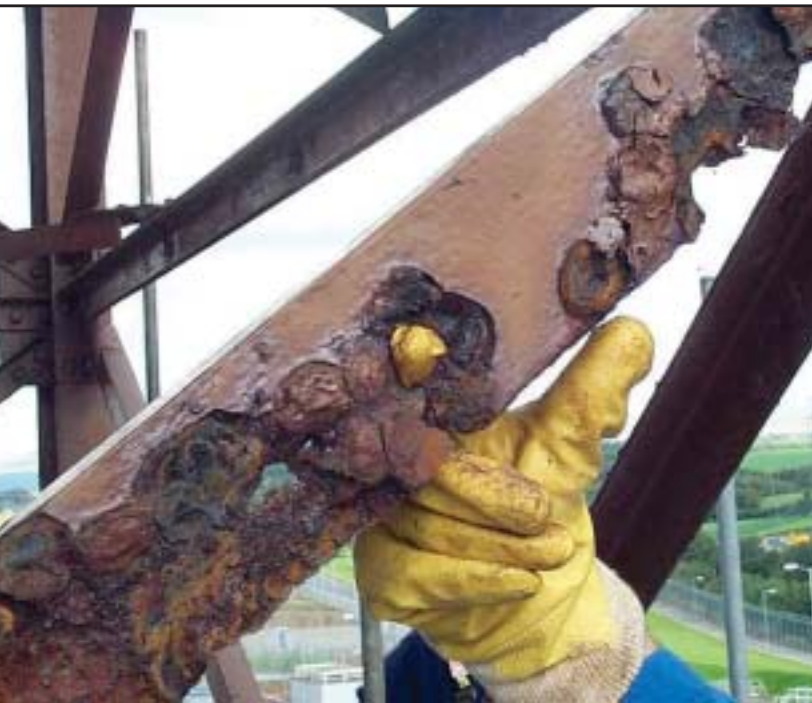
View of structural damage of east tower steelwork prior to the refurbishment necessary to gain access to the tunnel roof.

- The East Tower needed to be refurbished and structurally improved to enable access to the transfer tunnel roof.
- The East Tower Penthouse was stripped of redundant equipment, and the cladding on the tower was replaced, new lifting beams and hoists installed, and load bearing covers and transfer bogeys installed to safely transfer equipment.
- New ventilation connections had to be drilled into the roof of each waste compartment and then connected to new pressure protection lutes and into the existing ventilation extract ducting to enable argon to be drawn directly from each compartment.

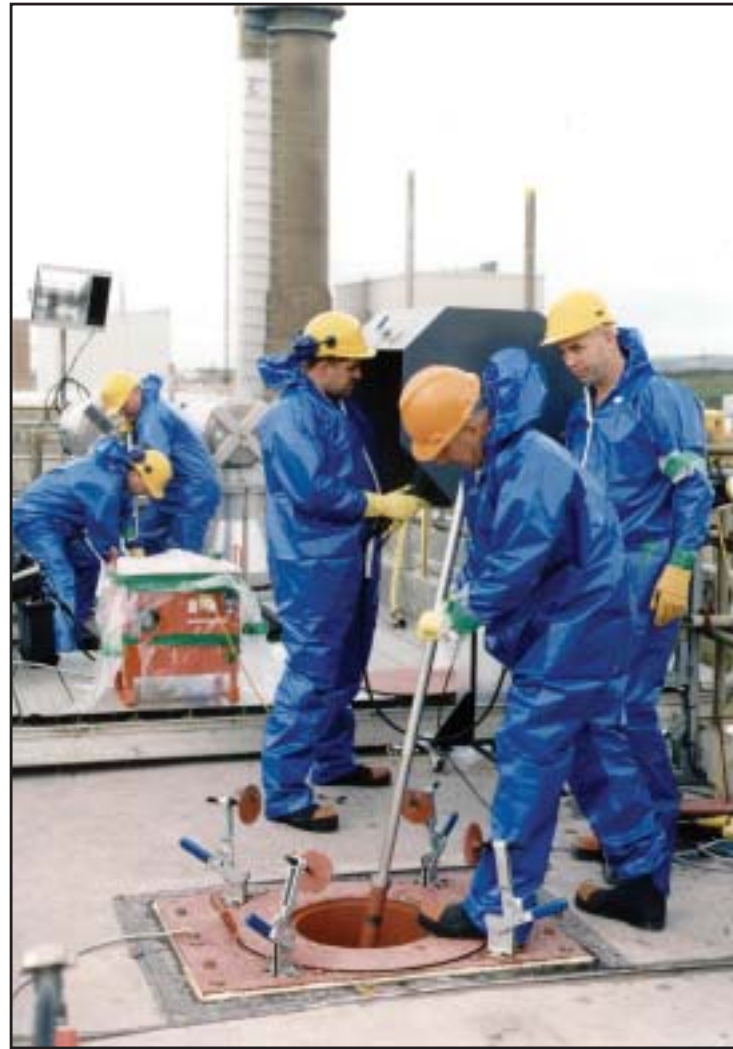
Working on top of the 20.85-m facility, workers dressed in protective gear use a Pokey Stick, designed by the group, to push waste located in the tunnel down into the charge holes that lead to the waste silo.

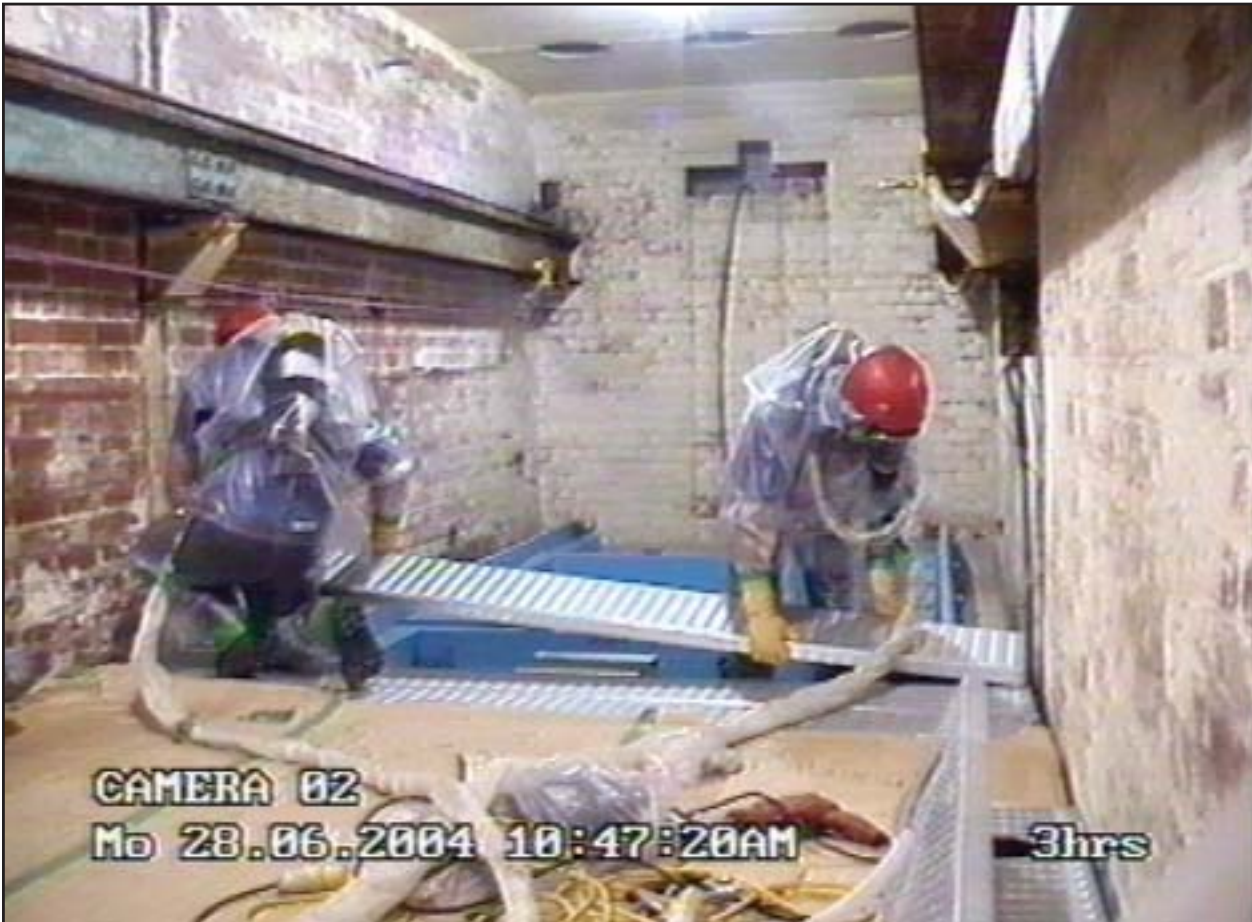
Workers dressed in supplied-air suits install decking material over the waste charge holes. (Photo taken from a video.)

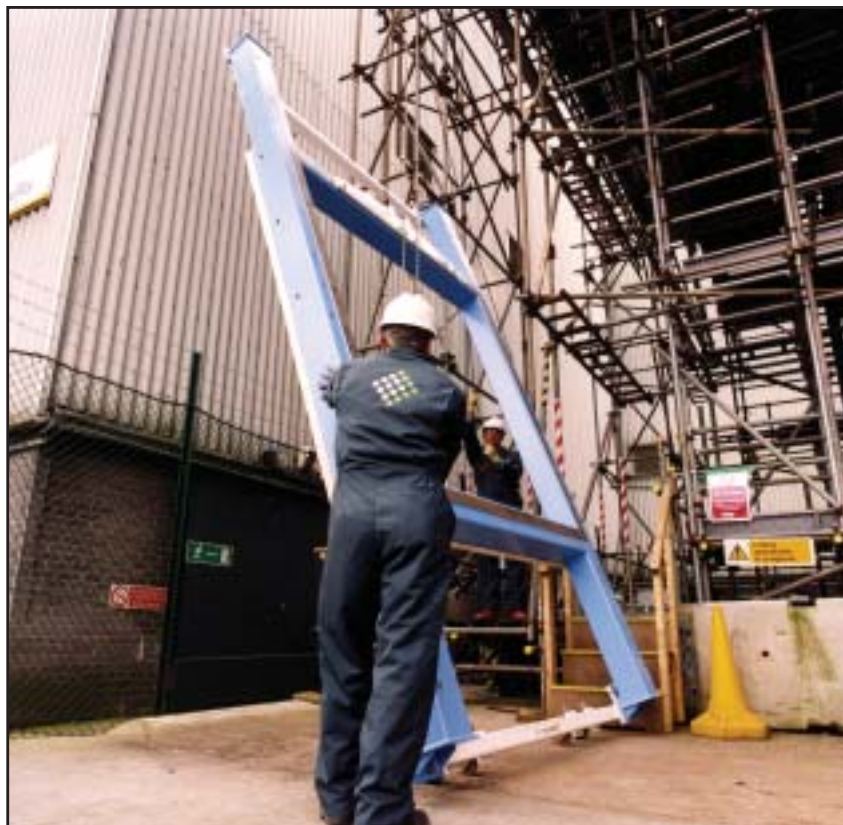
Initial entry into the transfer tunnel revealed that the floor of the tunnel was in a much poorer state than had been envisaged. Heavily corroded liners, loose or missing grouting, and widespread contamination necessitated a major clean-up and repair exercise prior to the installation of the main plugging frames. The first-stage trays had to be installed before this cleaning to remove the fall potential and improve the radiation shielding and argon retention. Upon completion of cleaning and repairing, workers painted a two-stage membrane onto the floor of the transfer tunnel to provide a base to seal against.

Workers hoist an h-frame mount used to cover the charge holes in the tunnel of the Pile Fuel Cladding Silo. These frames provided workers with a stable base to install decking and the waste charge hole covers.

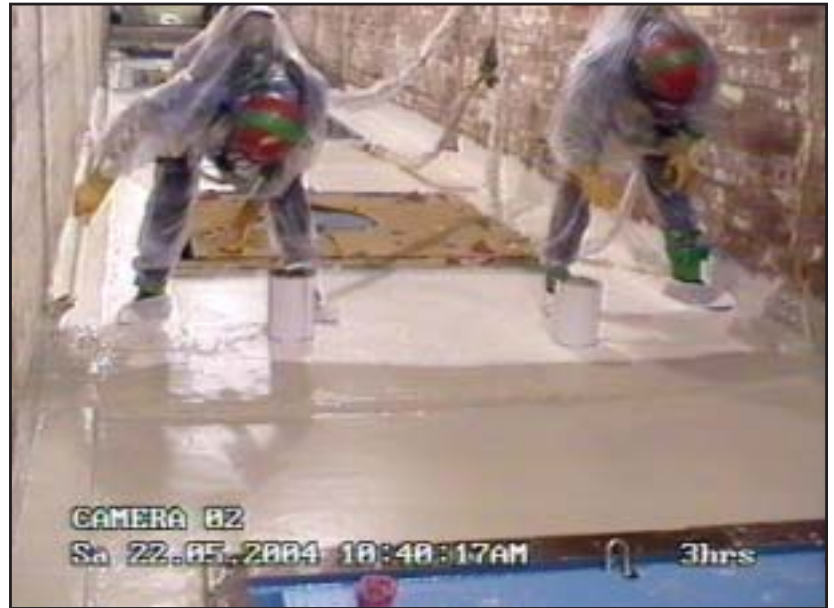
*Preparing the tunnel for demolition, workers dressed in supplied-air suits apply the final coat of paint, sealing the waste charge holes off from the tunnel. (Photo taken from a video.)*

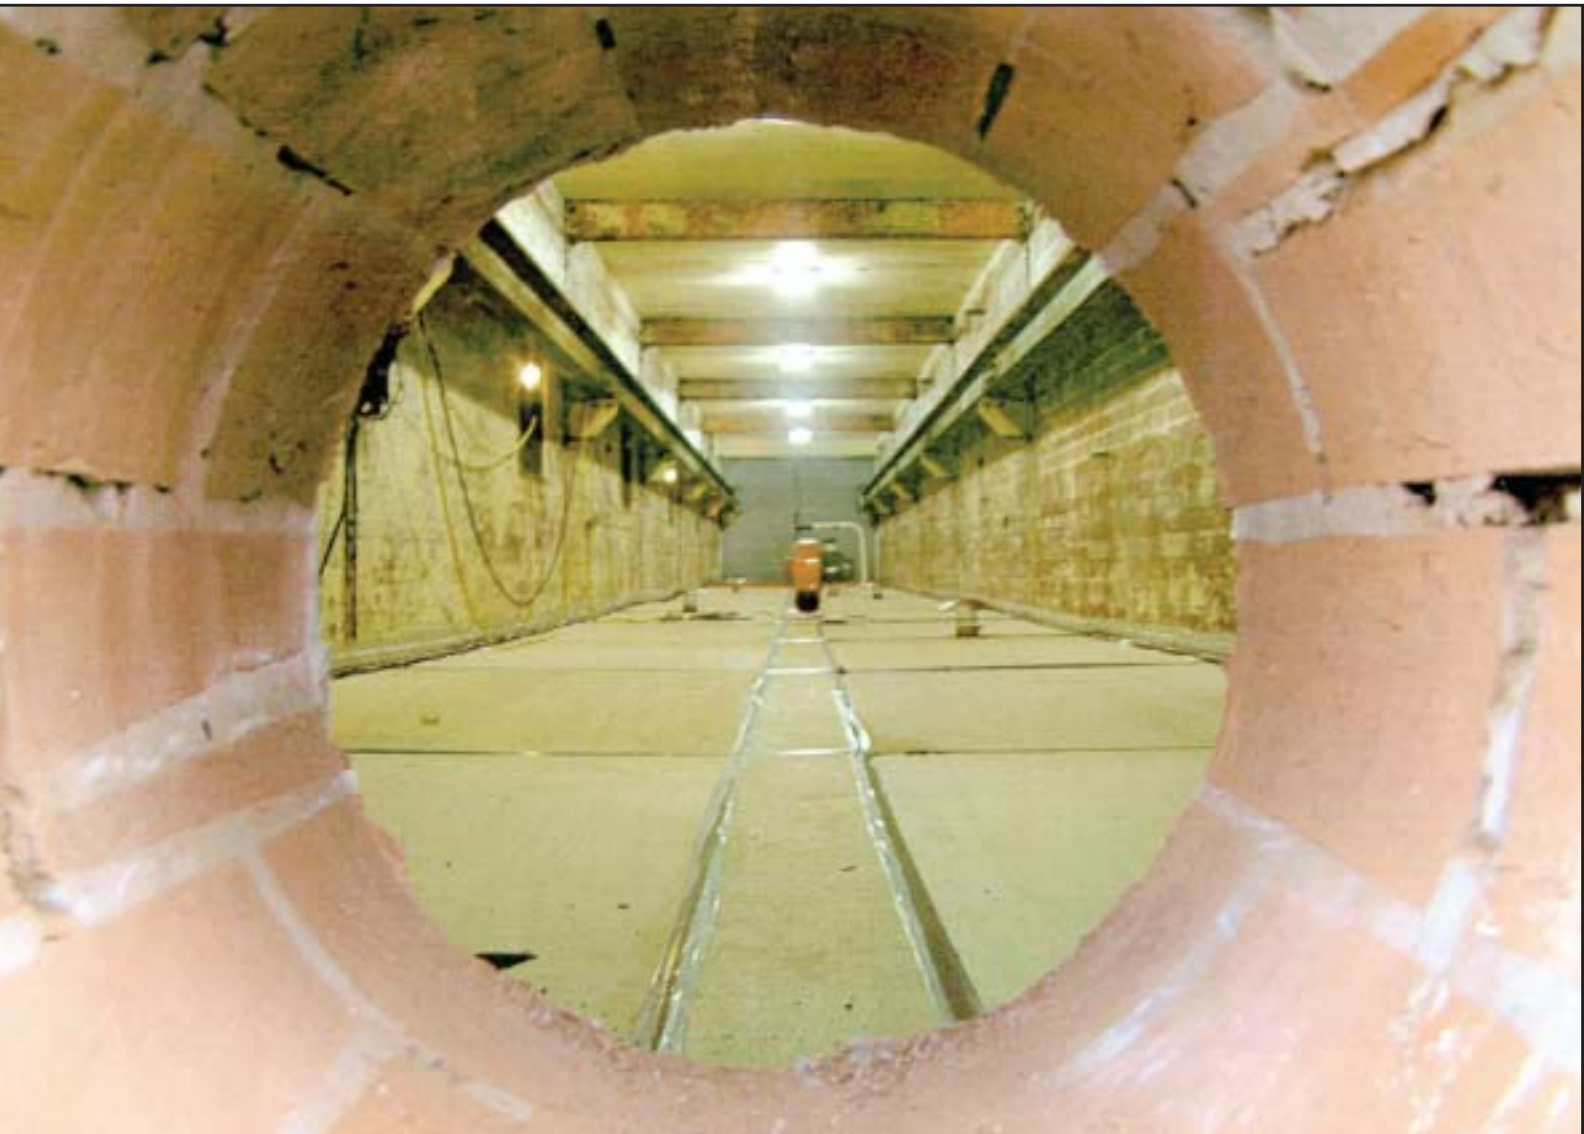
*Looking into the waste-cleared tunnel through a vent connection hole.*

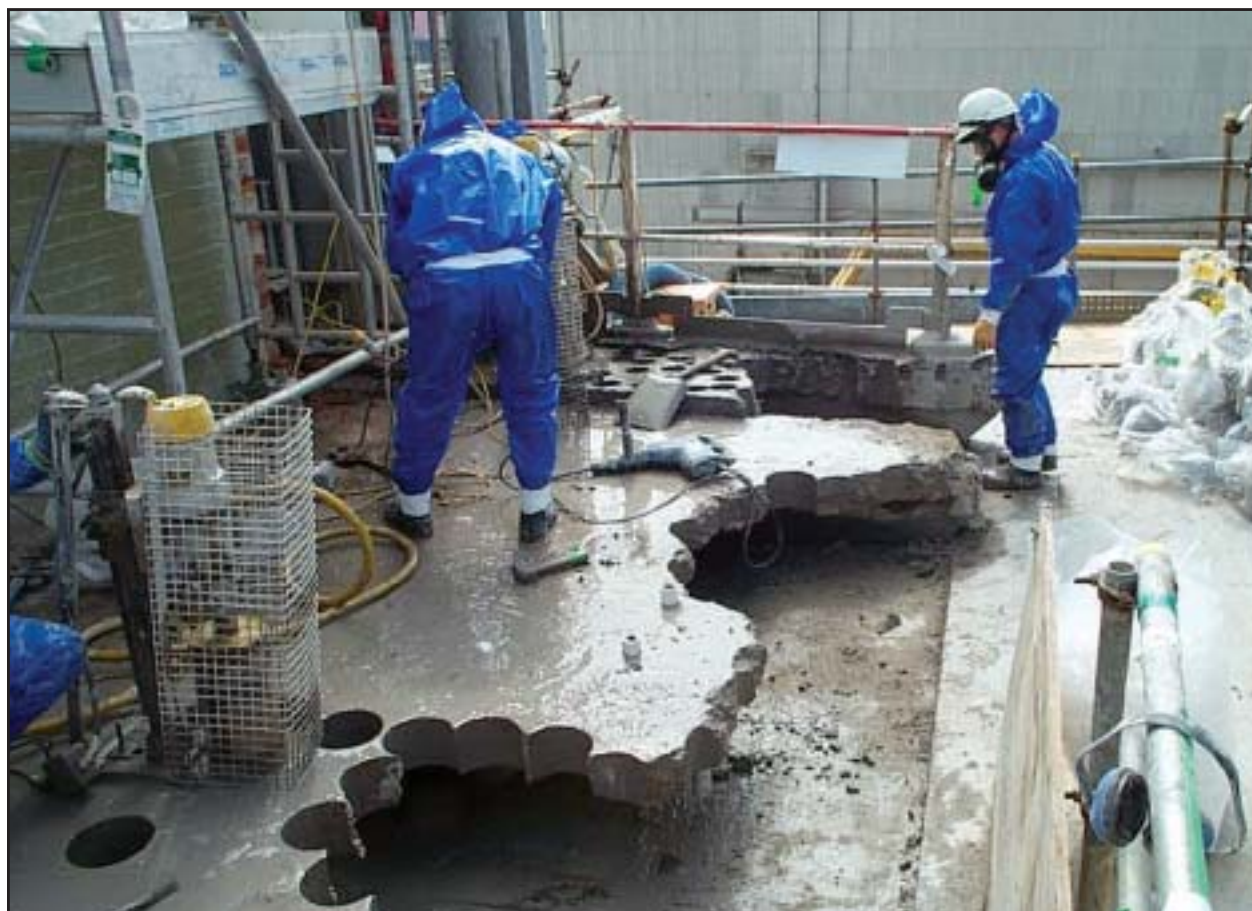
*Wall demolition in progress.*

Recently, following complete removal of the tunnel roof, the tunnel walls were demolished. Finally, the crew will construct low walls and install weatherproof covers, supported on the walls.
