Behind the scenes of Fermi-2's 15th refueling outage

THE 15TH REFUELING outage at DTE Energy's Fermi-2 nuclear power plant, an 1150-MWe boiling water reactor located in Newport, Mich., began in late March 2012 and ran for 38 days. During the outage, more than 16 000 planned inspection and equipment maintenance activities were carried out. Major jobs included the replacement of about one-third of the reactor fuel and the upgrading of the cables that connect the emergency diesel generators (EDG) to the plant and of the piping that supplies cooling water to the EDGs. These are long-term reliability improvements for the EDGs, a major backup safety system. In addition, new equipment that will improve grid reliability was installed in the transmission switchyard. The plant was reconnected to the grid on May 5.

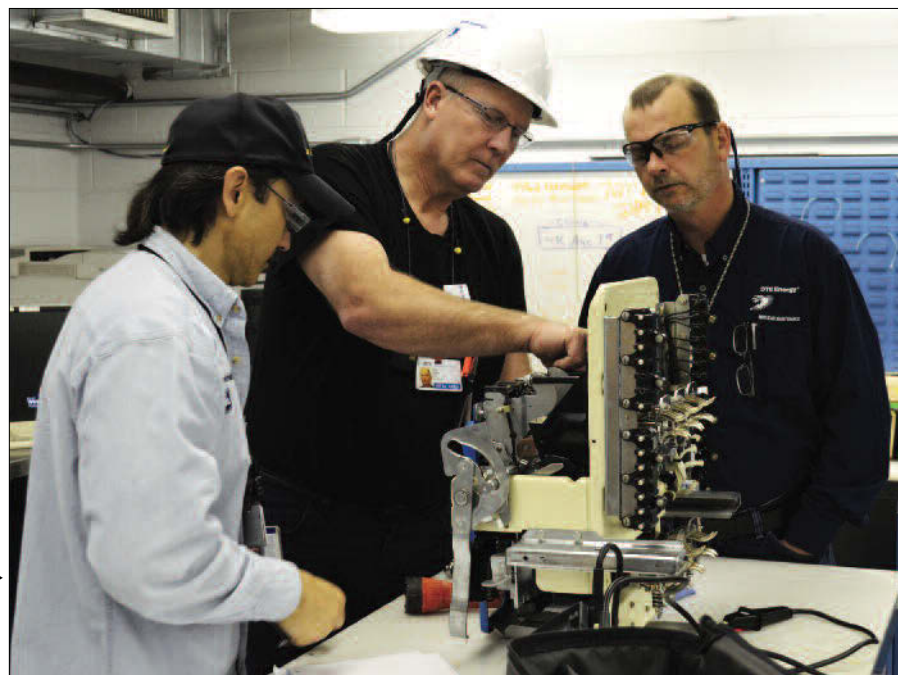
From left, Gabriel Verespec, Sam Hiner, and David Vanek perform preventive maintenance on a field circuit breaker for a motor generator.

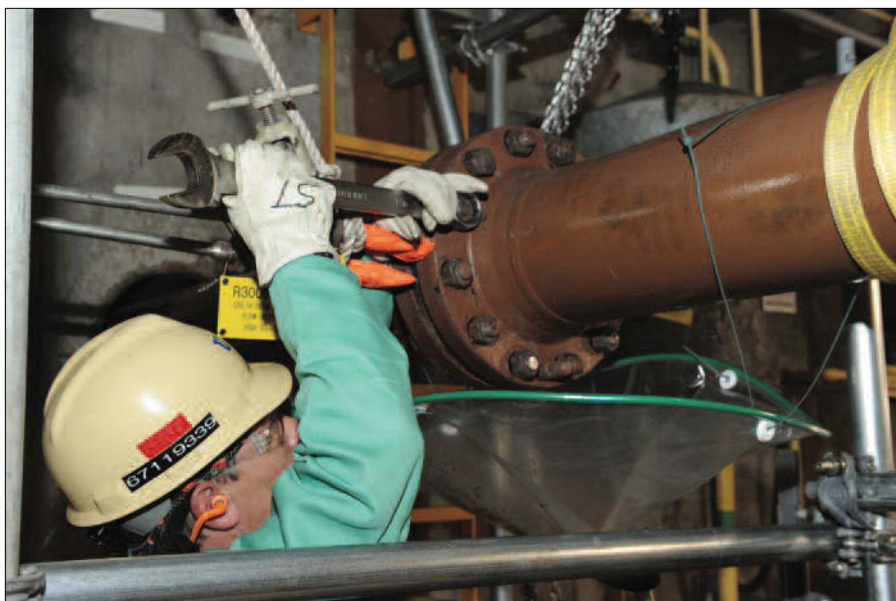
◀ A worker secures a bolt during a job to replace all service water piping for Fermi-2's emergency diesel generators (EDG). In all, crews removed and replaced more than 700 feet of piping in about 12 days. Preparation was the key to the success of this huge undertaking.

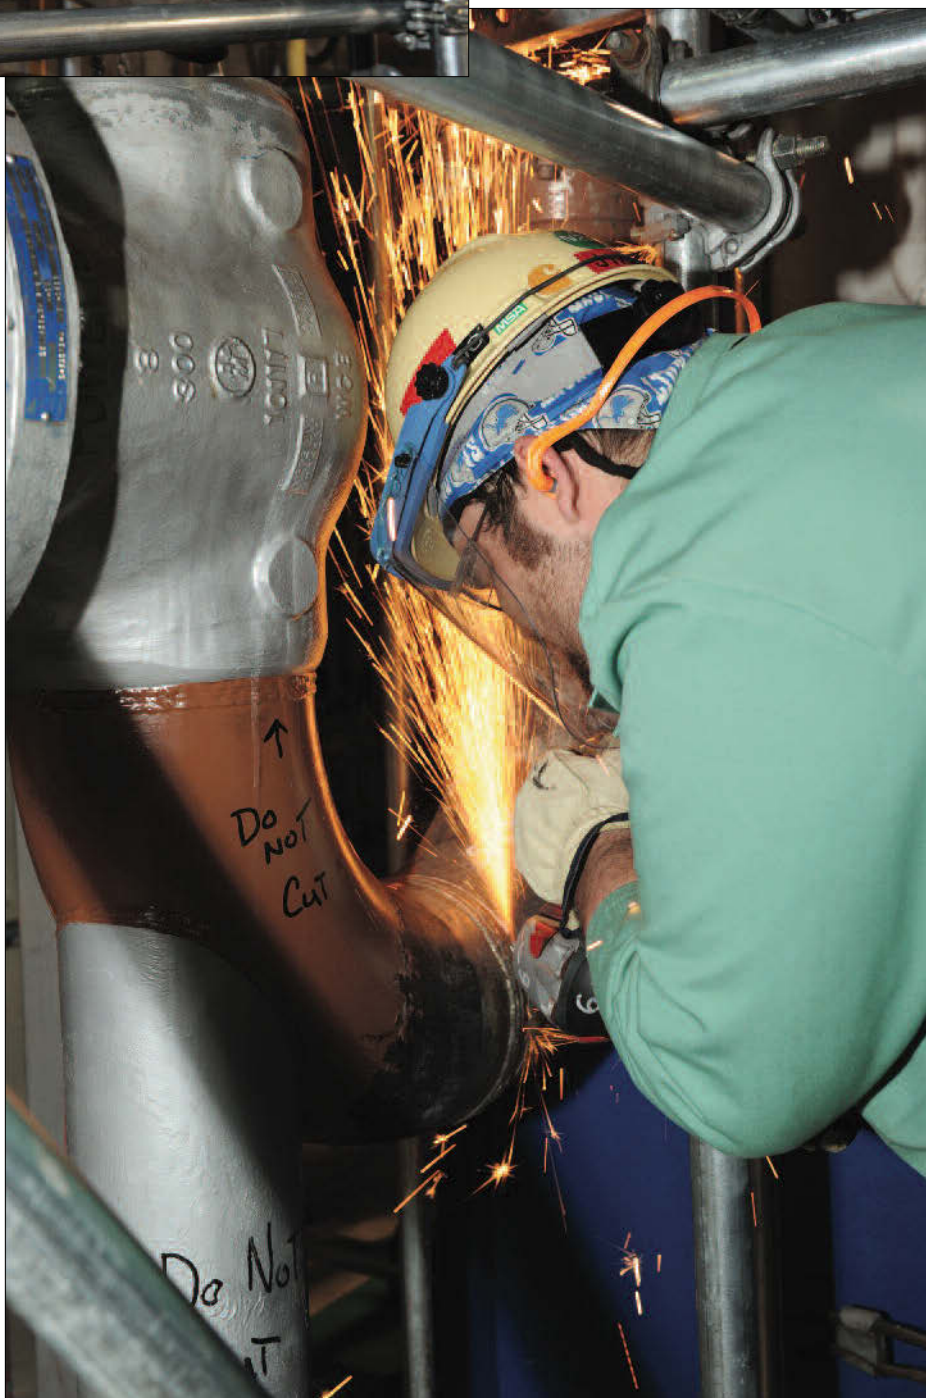
Also part of the service water piping for the EDGs, a worker cuts a portion of pipe that will be replaced during the outage. ▶

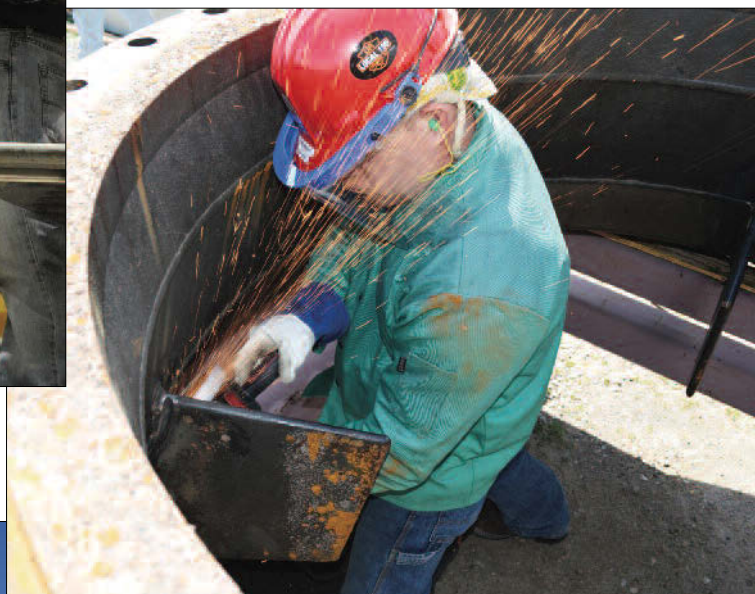
▼ Tommy Wright makes repairs to a separator vane on the suction bell of the No. 2 circulating water pump at the circulating water pump house.

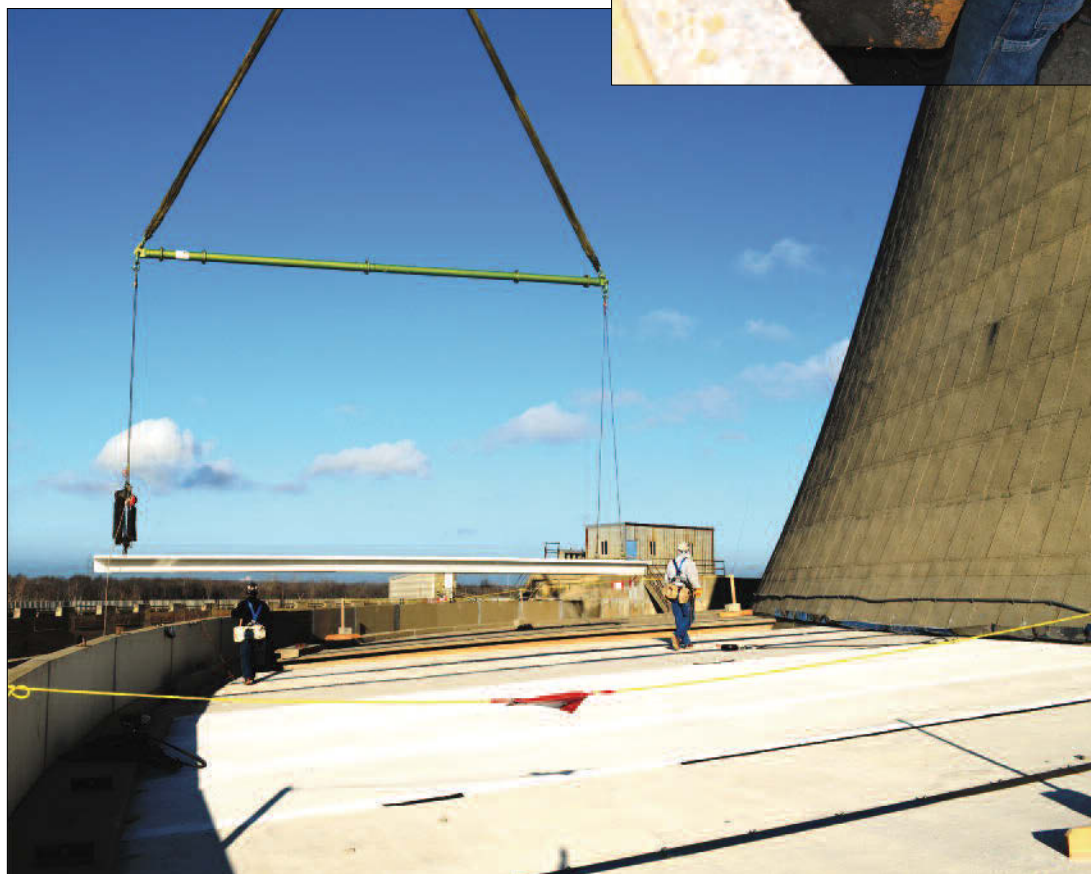
◀ A 160-foot-tall, 240-ton crane was used to replace 10 of the canopy covers on Fermi-2's north cooling tower. Each canopy cover weighs 13 200 lb, is 40 feet long, and measures 8.5 feet wide at one end and 6.5 feet wide at the other end.

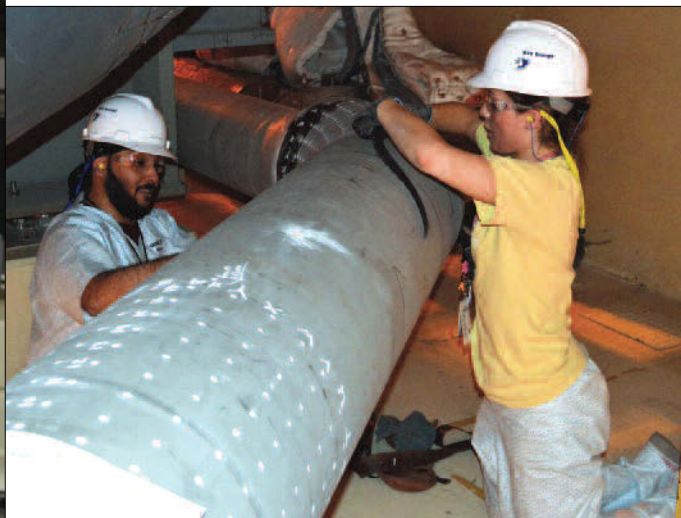
▲ Satbir Singh (left) and Elaine Belenky—both nuclear engineers—work on Fermi-2's flow-accelerated corrosion program. Pipe wall thickness is tested during each outage, and if the pipe walls are found to be thinner than allowable, corrective action is taken.

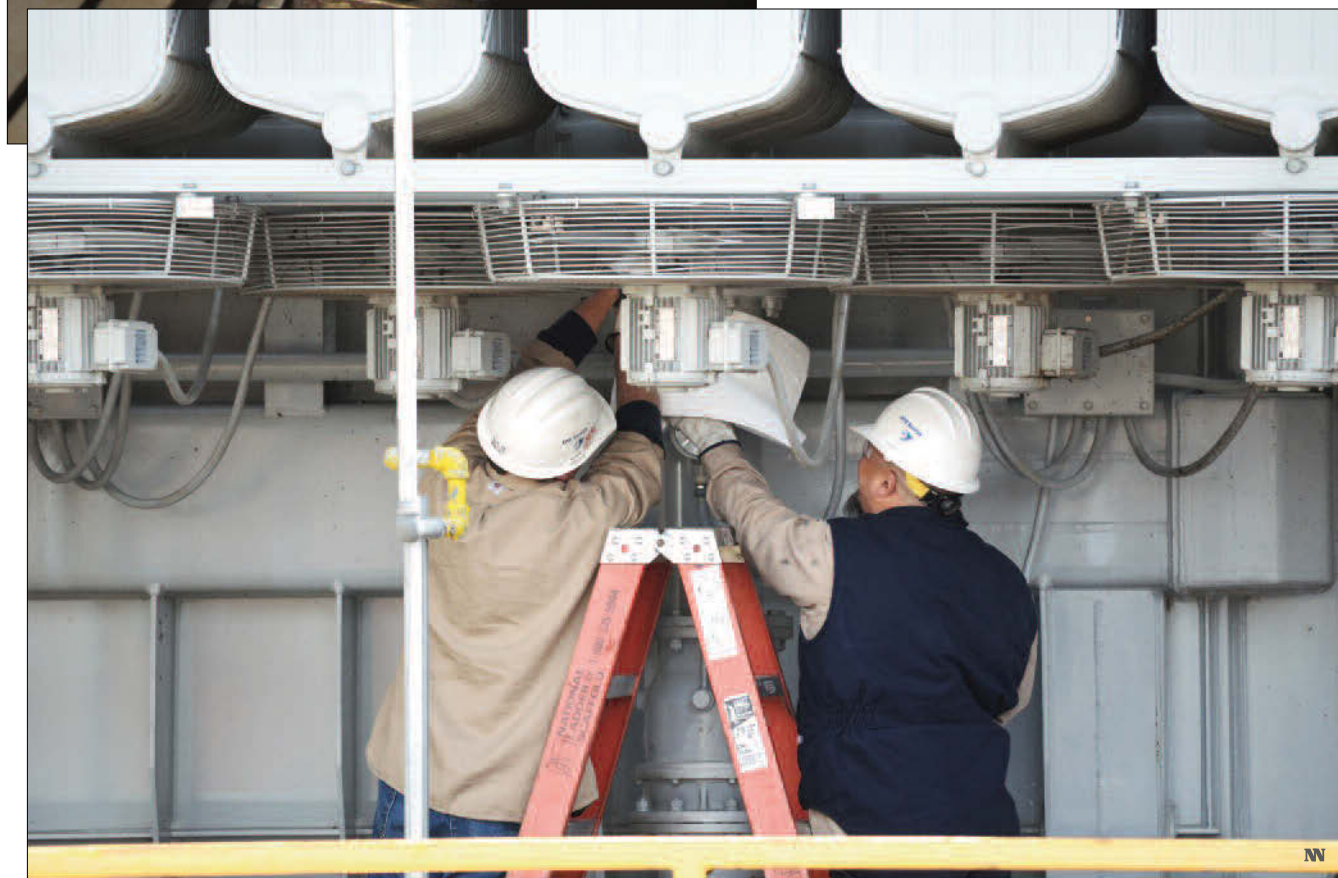
▼ Fermi-2 workers prepare to change out four oil pumps on one of the plant's main unit transformers.
