# Working together to enhance nuclear reactor safety

*Information from examinations at the affected reactors at Fukushima Daiichi is being used to enhance reactor safety in U.S. operating plants, plants under construction, and future nuclear power plants.*

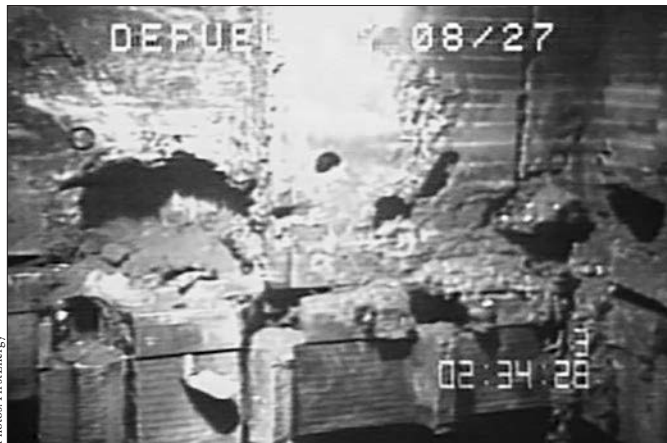
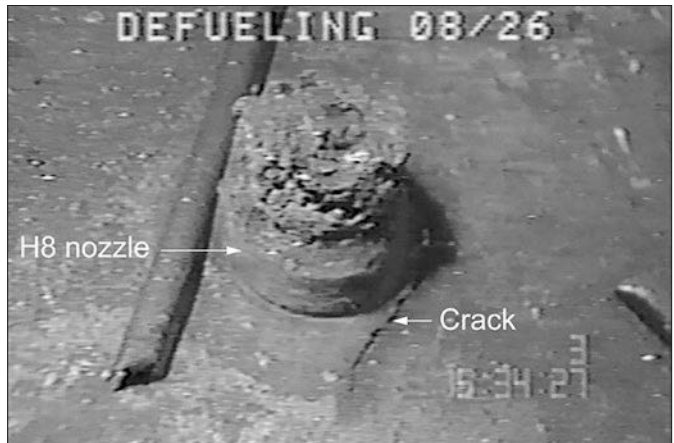
**Fig. 1.** TMI-2 video examinations revealed locations where damage to the core barrel (left) and nozzles (right) was more severe.

camera inserted into the reactor vessel revealed that nearly half of the fuel had been damaged and relocated from its initial core location. Subsequent examinations, including evaluations of relocated fuel and structural materials, and more detailed photographic images, such as those shown in Fig. 1, were used to determine the extent to which core material had relocated and the damage to structures within the vessel. This allowed defueling efforts to focus on developing and deploying the needed technologies to ensure that activities could be successfully completed in a timely fashion. Ultimately, TMI-2 examination data benefited the global nuclear community.

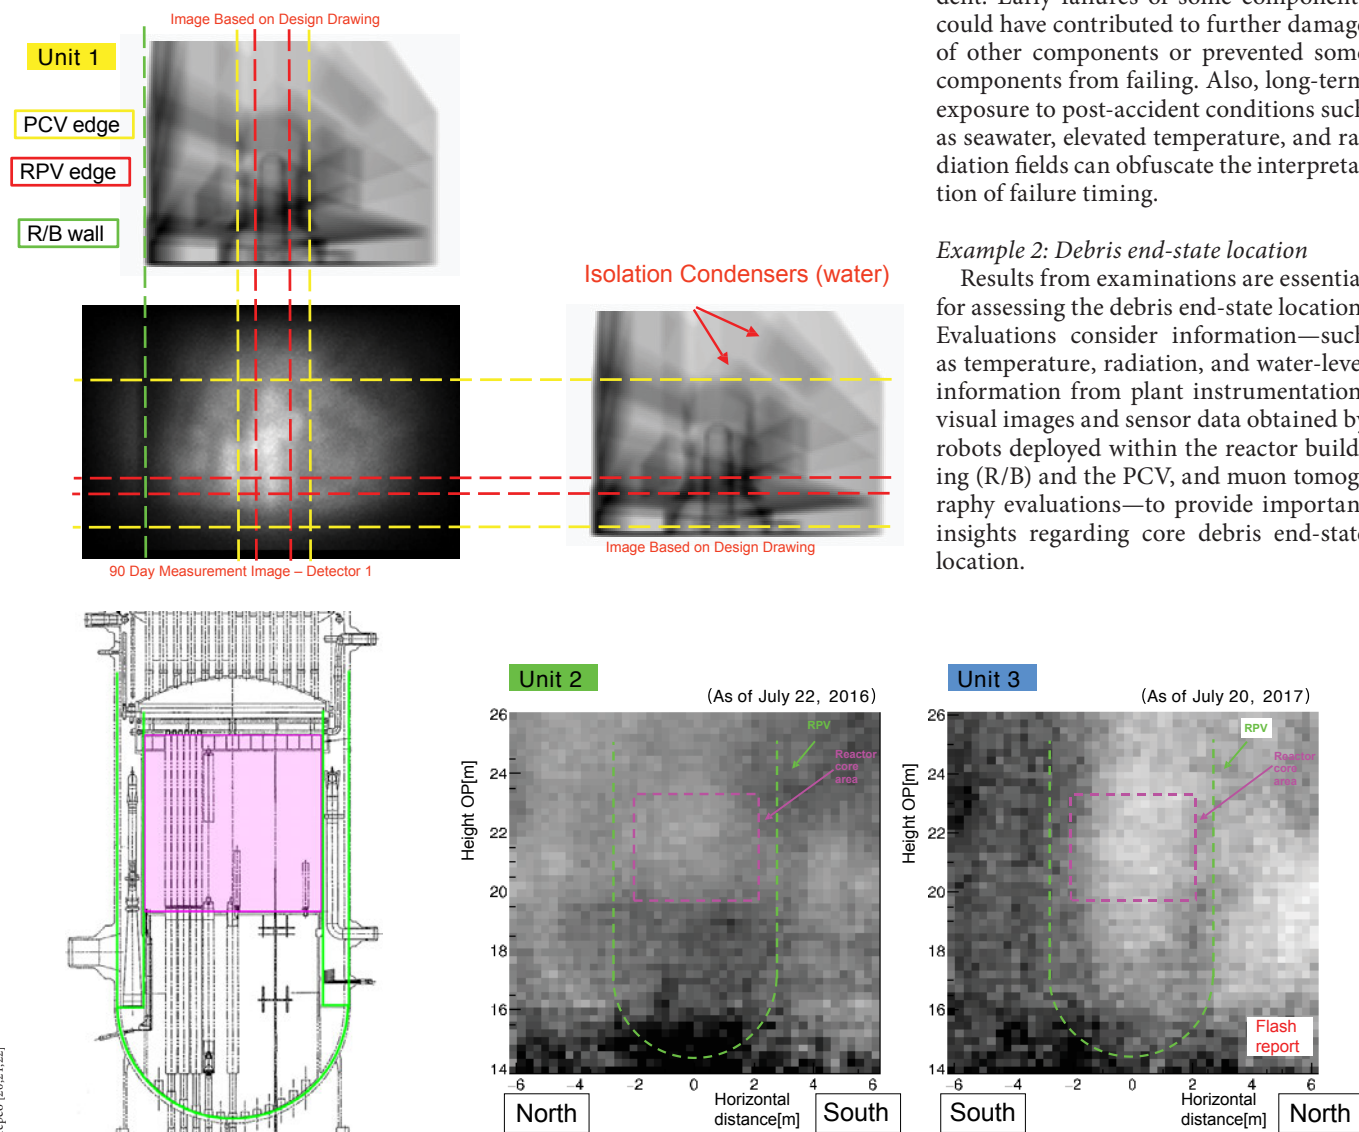
**Fig. 3.** Images of Units 1, 2, and 3 reactor vessels obtained using muon tomography methods. The darker regions correspond to denser materials, such as fuel.

Muon tomography measurements using scintillation detectors are another information source for evaluating debris end-state conditions for Units 1, 2, and 3. Using this approach, high-density fuel should show up as dark regions in the images due to muon attenuation. As shown in Fig. 3, the core region appears to be essentially devoid of core material in each unit, which is consistent with previously described system-level code analyses. The potential for debris to have relocated to the bottom of the Unit 2 and Unit 3 reactor vessels is also supported by thermocouple data.
