Behind the scenes of Fermi-2's 15th refueling outage

THE 15TH REFUELING outage at DTE Energy's Fermi-2 nuclear power plant, an 1150-MWe boiling water reactor located in Newport, Mich., began in late March 2012 and ran for 38 days. During the outage, more than 16 000 planned inspection and equipment maintenance activities were carried out. Major jobs included the replacement of about one-third of the reactor fuel and the upgrading of the cables that connect the emergency diesel generators (EDG) to the plant and of the piping that supplies cooling water to the EDGs. These are long-term reliability improvements for the EDGs, a major backup safety system. In addition, new equipment that will improve grid reliability was installed in the transmission switchyard. The plant was reconnected to the grid on May 5.

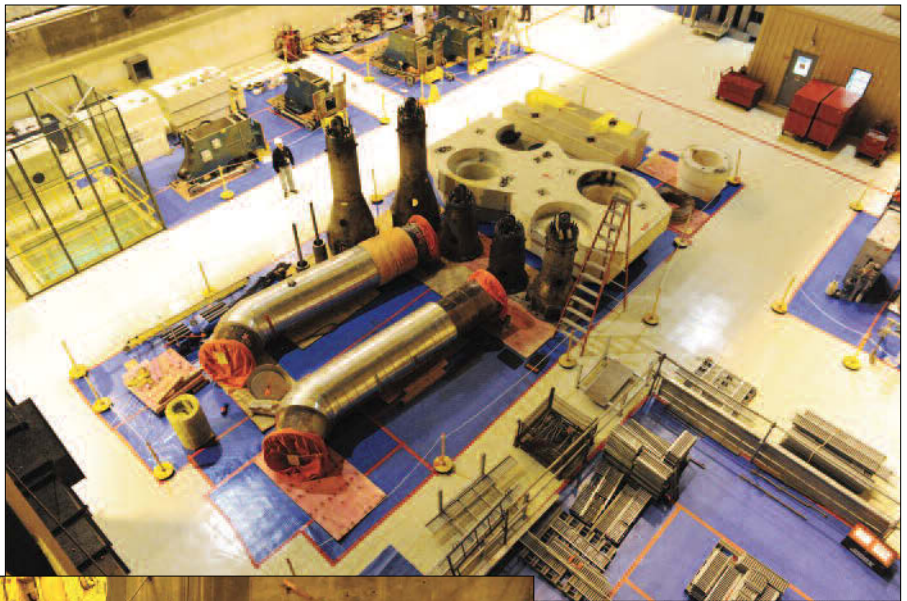
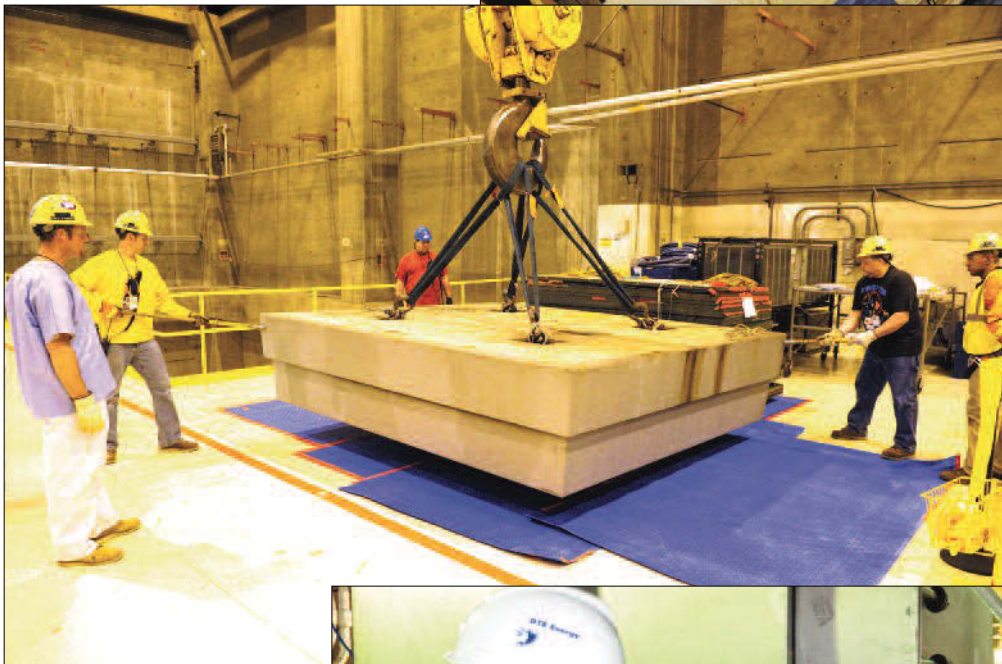
On the third floor of Fermi-2's turbine building, equipment from various valves connected to the low-pressure turbine is staged on the floor.

Also on the third floor of the turbine building, workers move a 20-ton cap to give crews access to a filter for cleaning during the plant's 15th refueling outage.

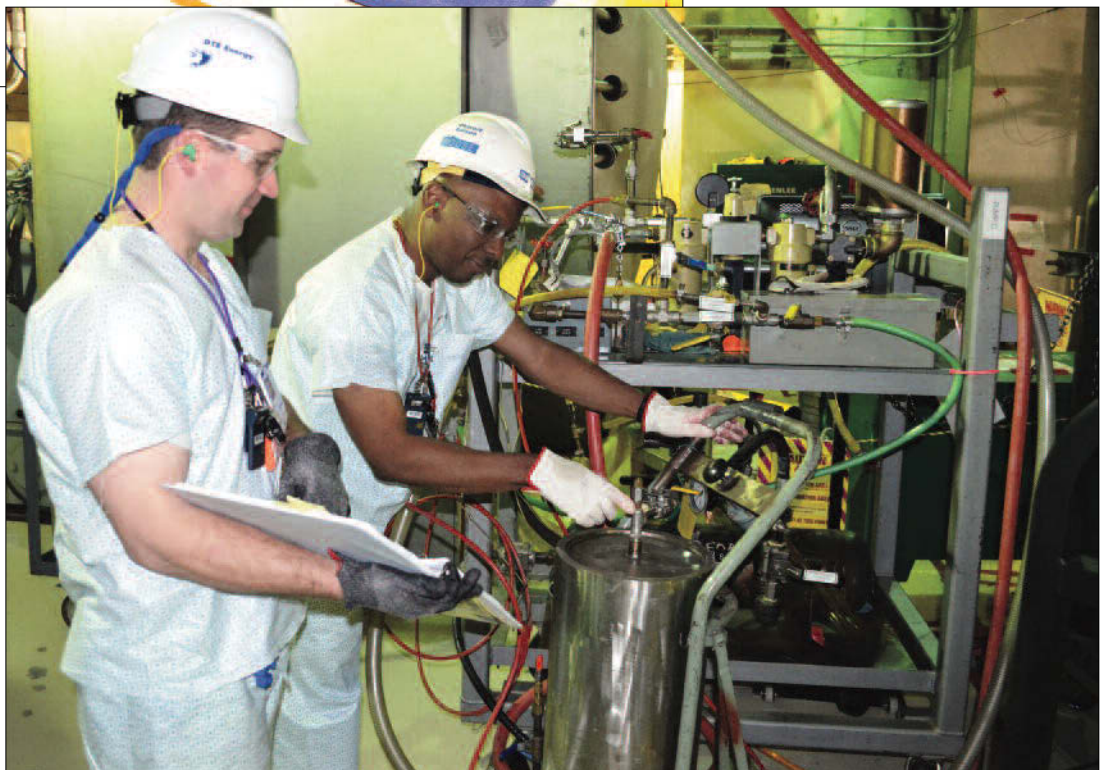
Mark Alward (left) and Ron Reddick conduct a test of the check valves and other components that are part of Fermi-2's primary containment system. The work done on the valves was part of a job that stretched over two outages and was finished during this refueling outage.

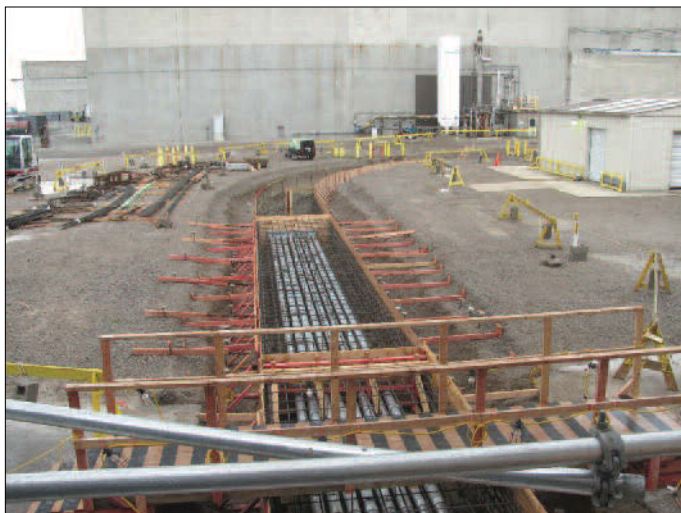
◀ As part of a multiyear project to replace the cables that connect the EDGs to the plant, new trenches were built to run the cables. More than 800 feet of cable was replaced during Fermi-2's 15th refueling outage. For the entire project, more than 30 tons of rebar, 700 feet of 4-inch conduit, and 800 yards of concrete were used to construct the cable duct banks.

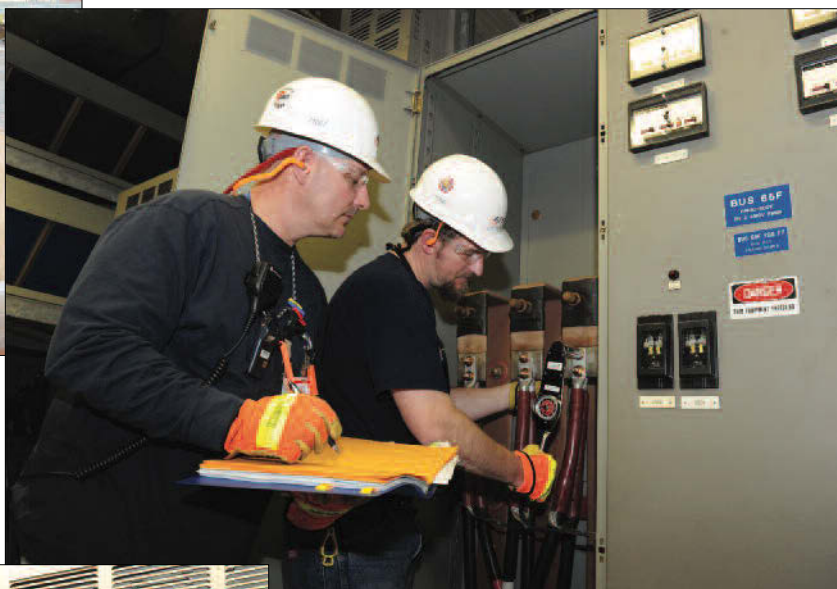
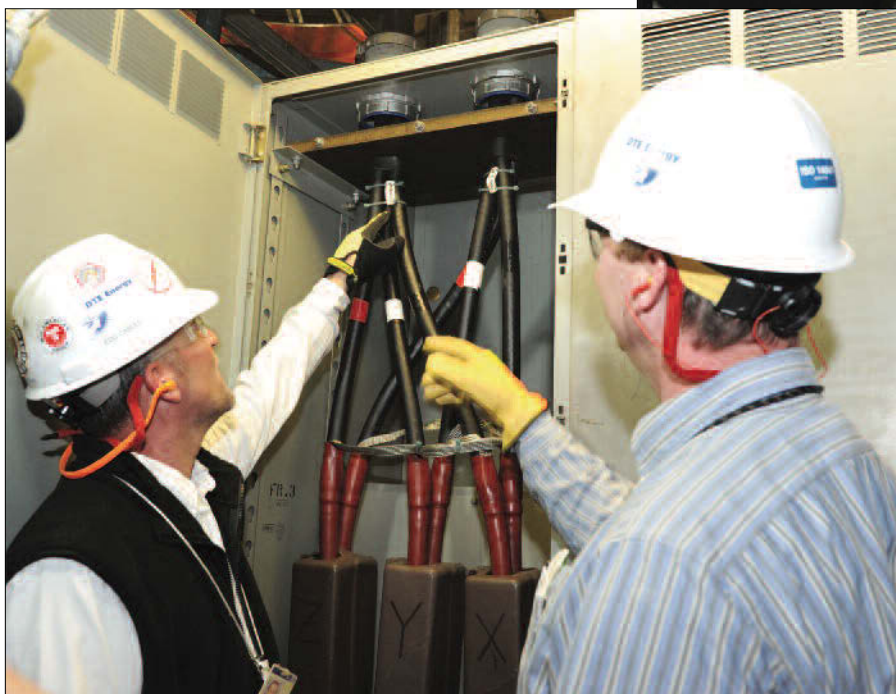
◀ Inside the residual heat removal building at Fermi-2, Rick Clear (left) and Glenn Paulette check the connections for the cables that provide electricity to the plant from the EDGs. Clear and his team replaced more than 800 feet of cable to complete the project.

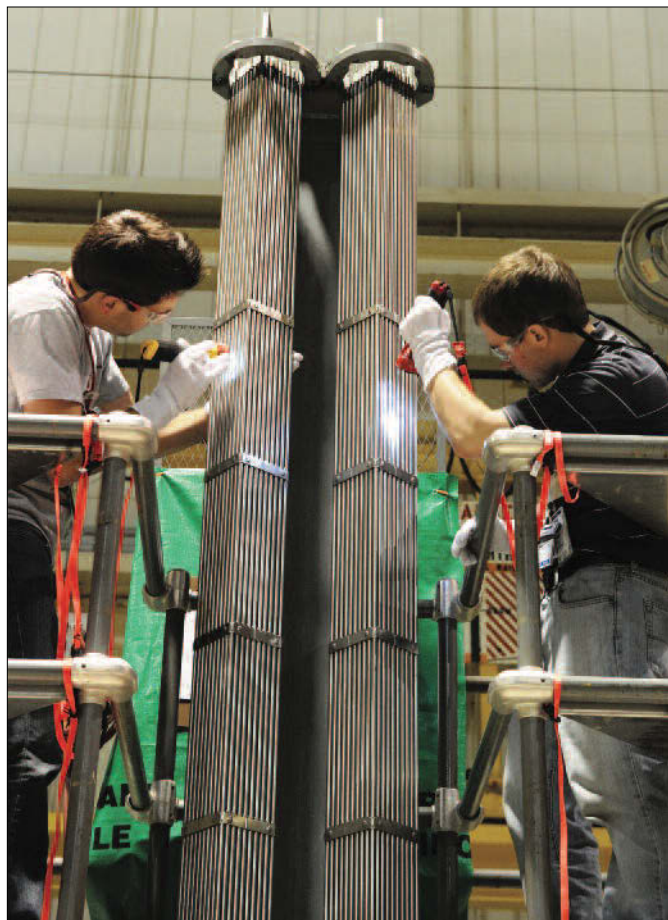
◀ On the refueling floor in Fermi-2's reactor building, two engineers inspect new nuclear fuel, looking for any imperfections.

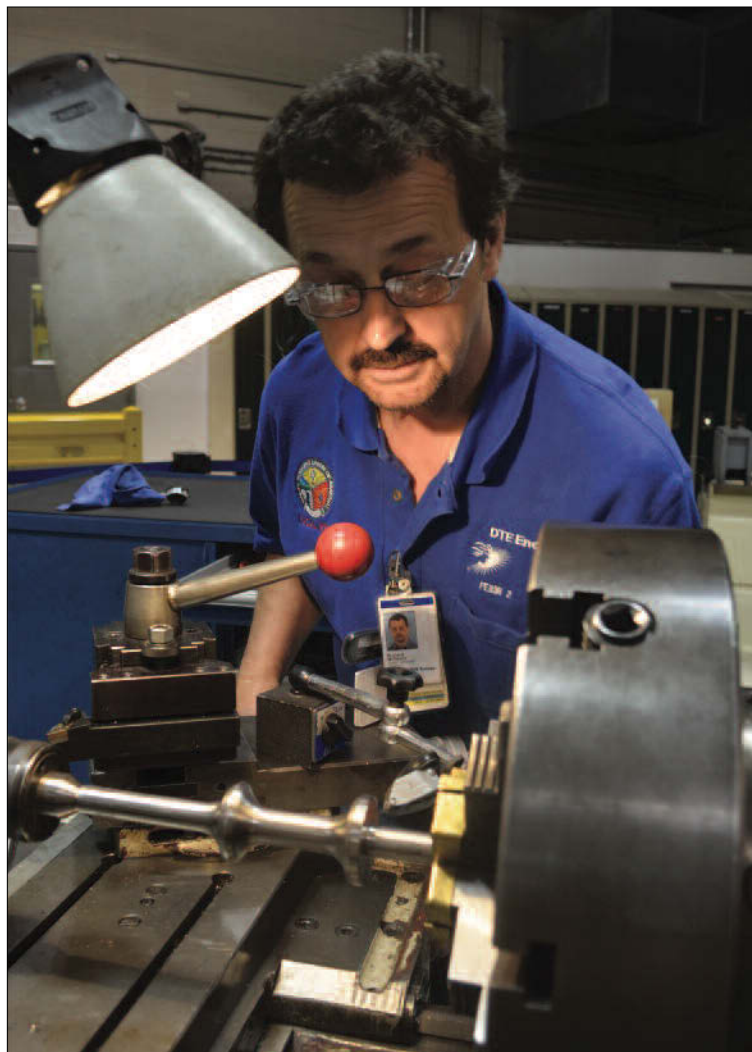
◀ Rich McDevitt, a journeyman mechanic at Fermi-2, works on a valve component in the machine shop.
